# HIGHWAY RESEARCH REPORT

## THE SAN FERNANDO EARTHQUAKE

### SOILS AND GEOLOGIC INVESTIGATIONS IN RELATION TO HIGHWAY DAMAGE

**NO. M & R 632119**

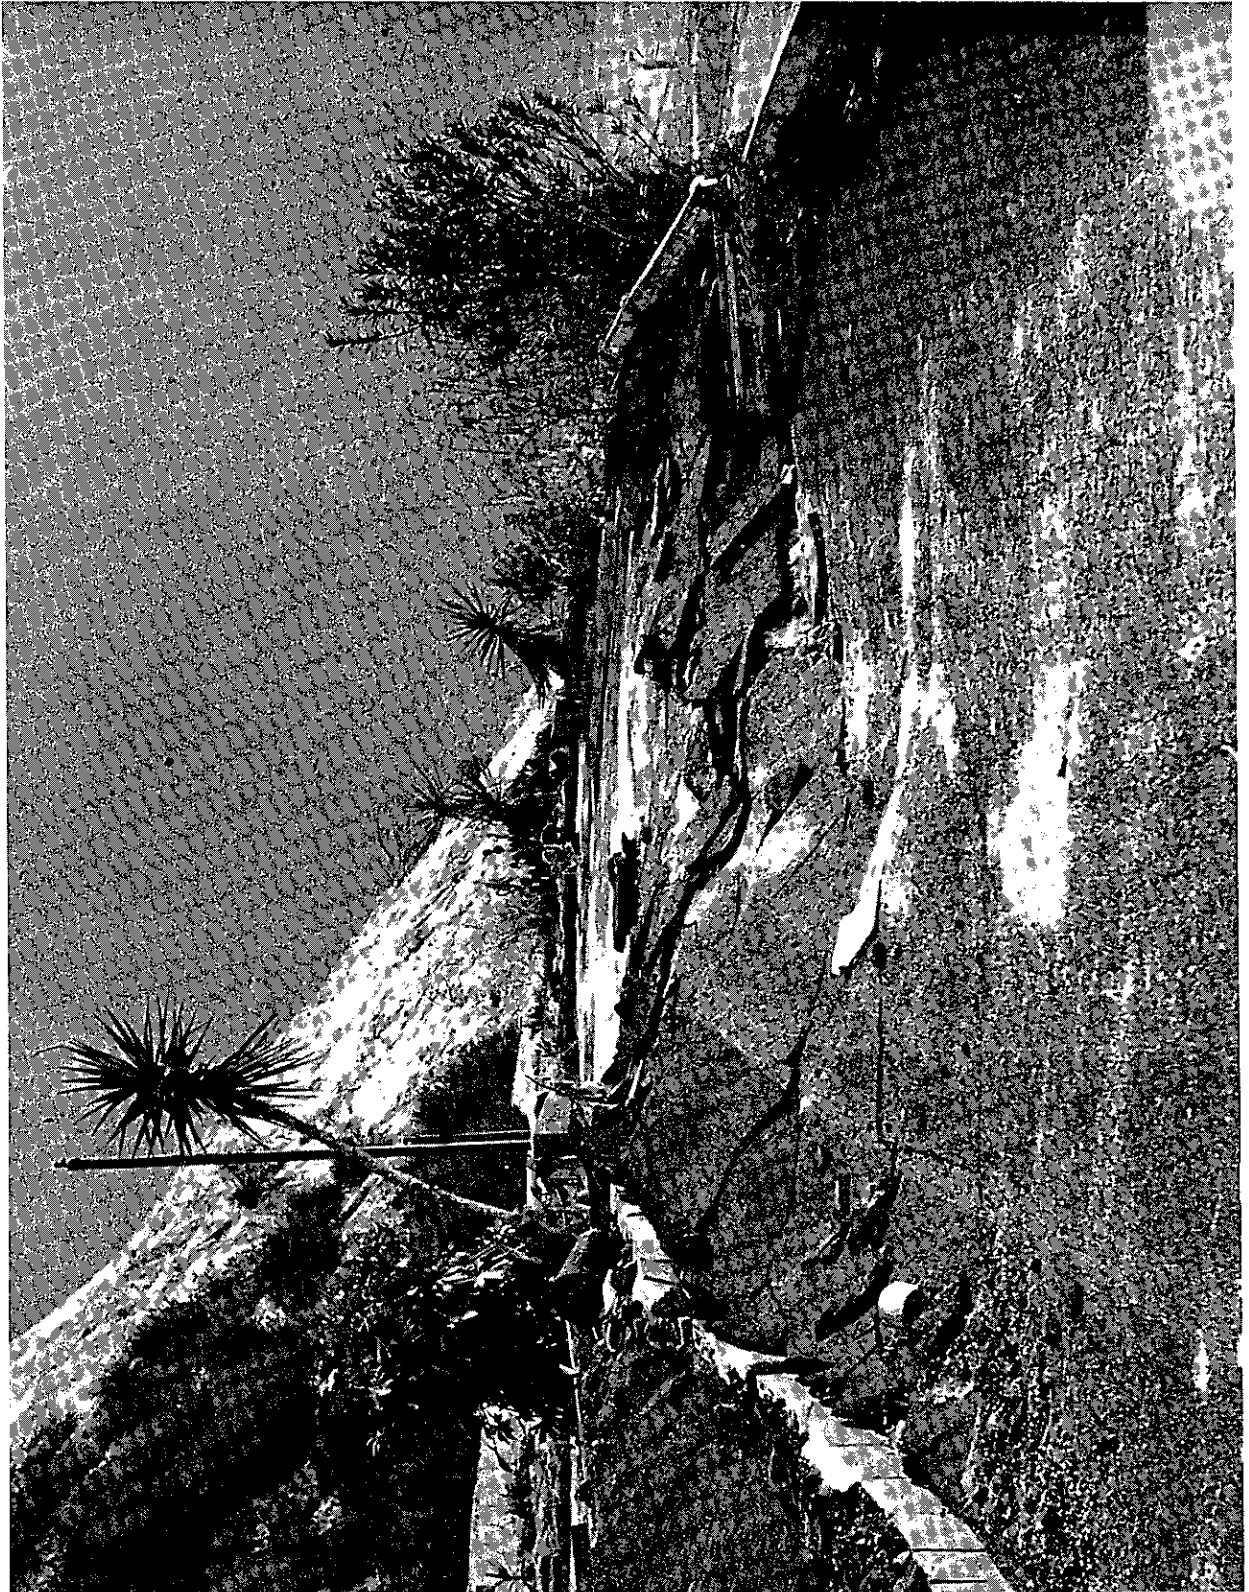
The Tujunga Fault, where it is exposed in the bedrock east of the Foothill Nursing Home as shown on the map, dips from about  $15^{\circ}$  north to nearly vertical. The north block has been thrust over the south block. Six hundred feet west of Lopez Canyon Road (Figure 3) a fence that crosses the fault scarp at about a  $45^{\circ}$  angle has been shortened 2.7 feet along the fence line and the north side elevated about two feet. At this location the fault appears to parallel bedding planes that dip  $30^{\circ}$  north and strike east-west. The observed trace of the Tujunga Fault is nearly continuous to the east from the east map limit for a distance of approximately three miles along the base of the foothills. Fault breaks that occurred further east have been mapped by Kamb, et al (5).

Figure 3 - Looking north at Tujunga Fault scarp 600 feet west of Lopez Canyon Road.

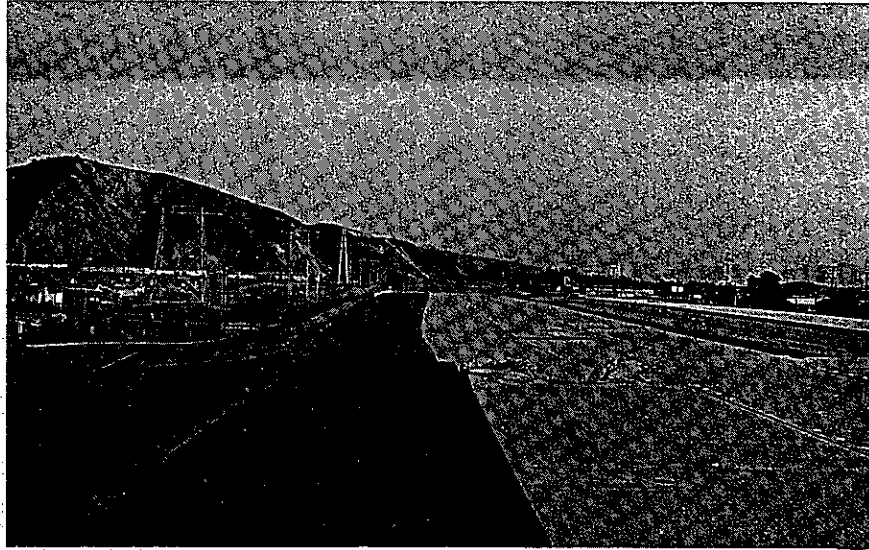
Figure 4 - Looking southeast at Sylmar Fault trace across Route 210.

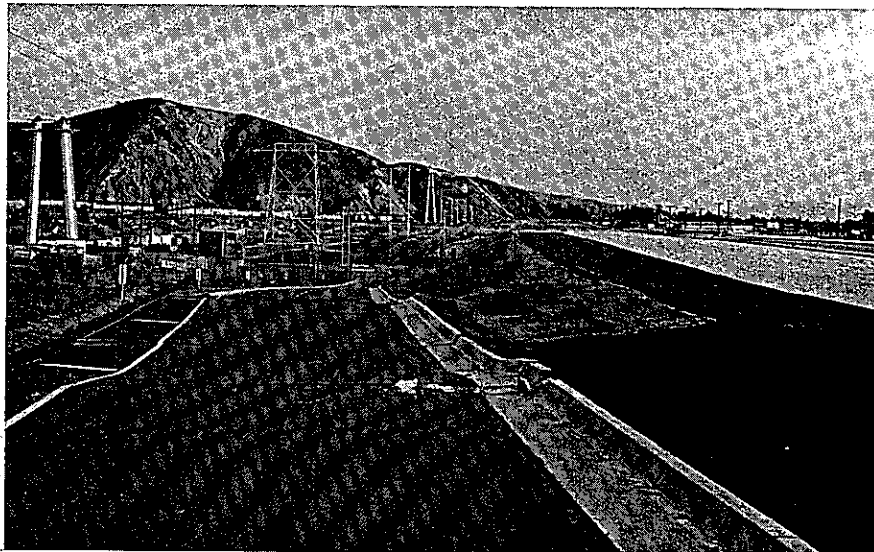
Figure 5 - Looking across the Sylmar Fault trace across Route 210/MacLay Street westbound on ramp.

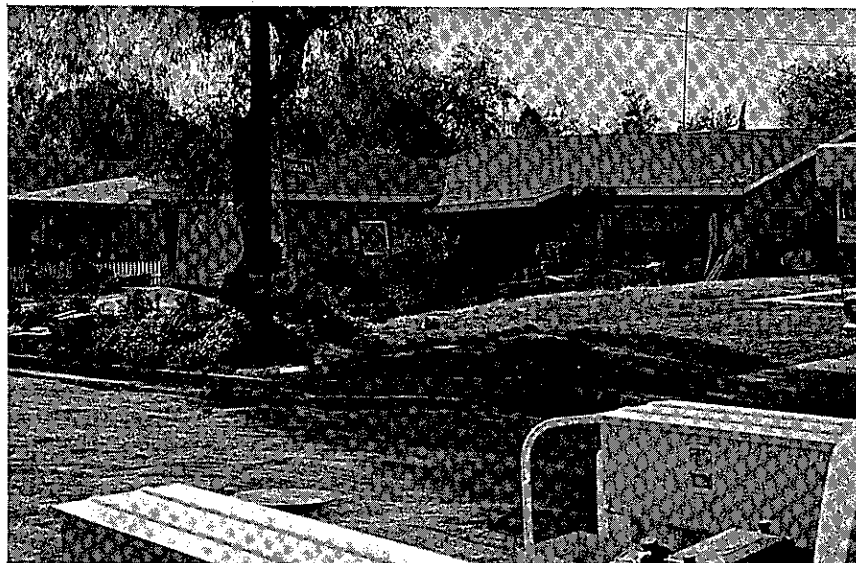
Figure 6 - Looking west at the Sylmar Fault trace across the intersection of Adelphia Avenue and Harding Street.

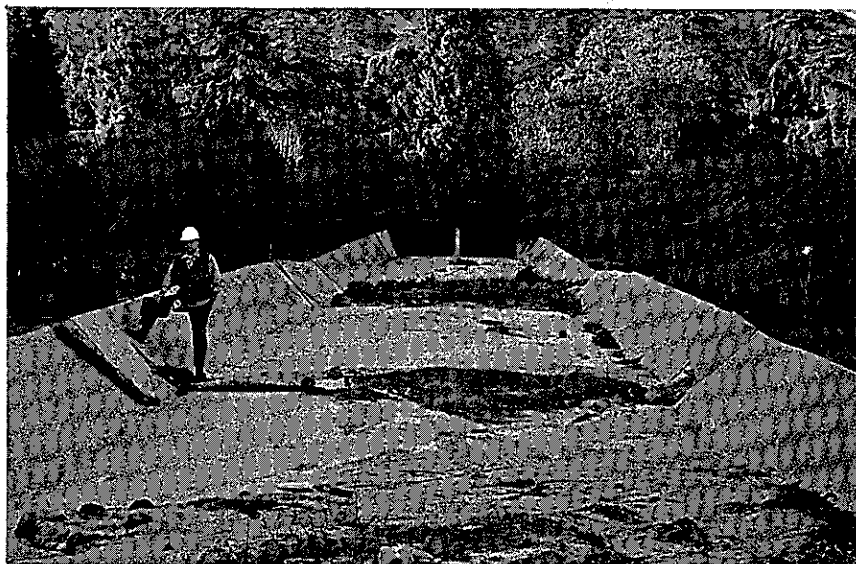
Figure 7 - Looking north at concrete channel that shows displacement that occurred prior to earthquake.

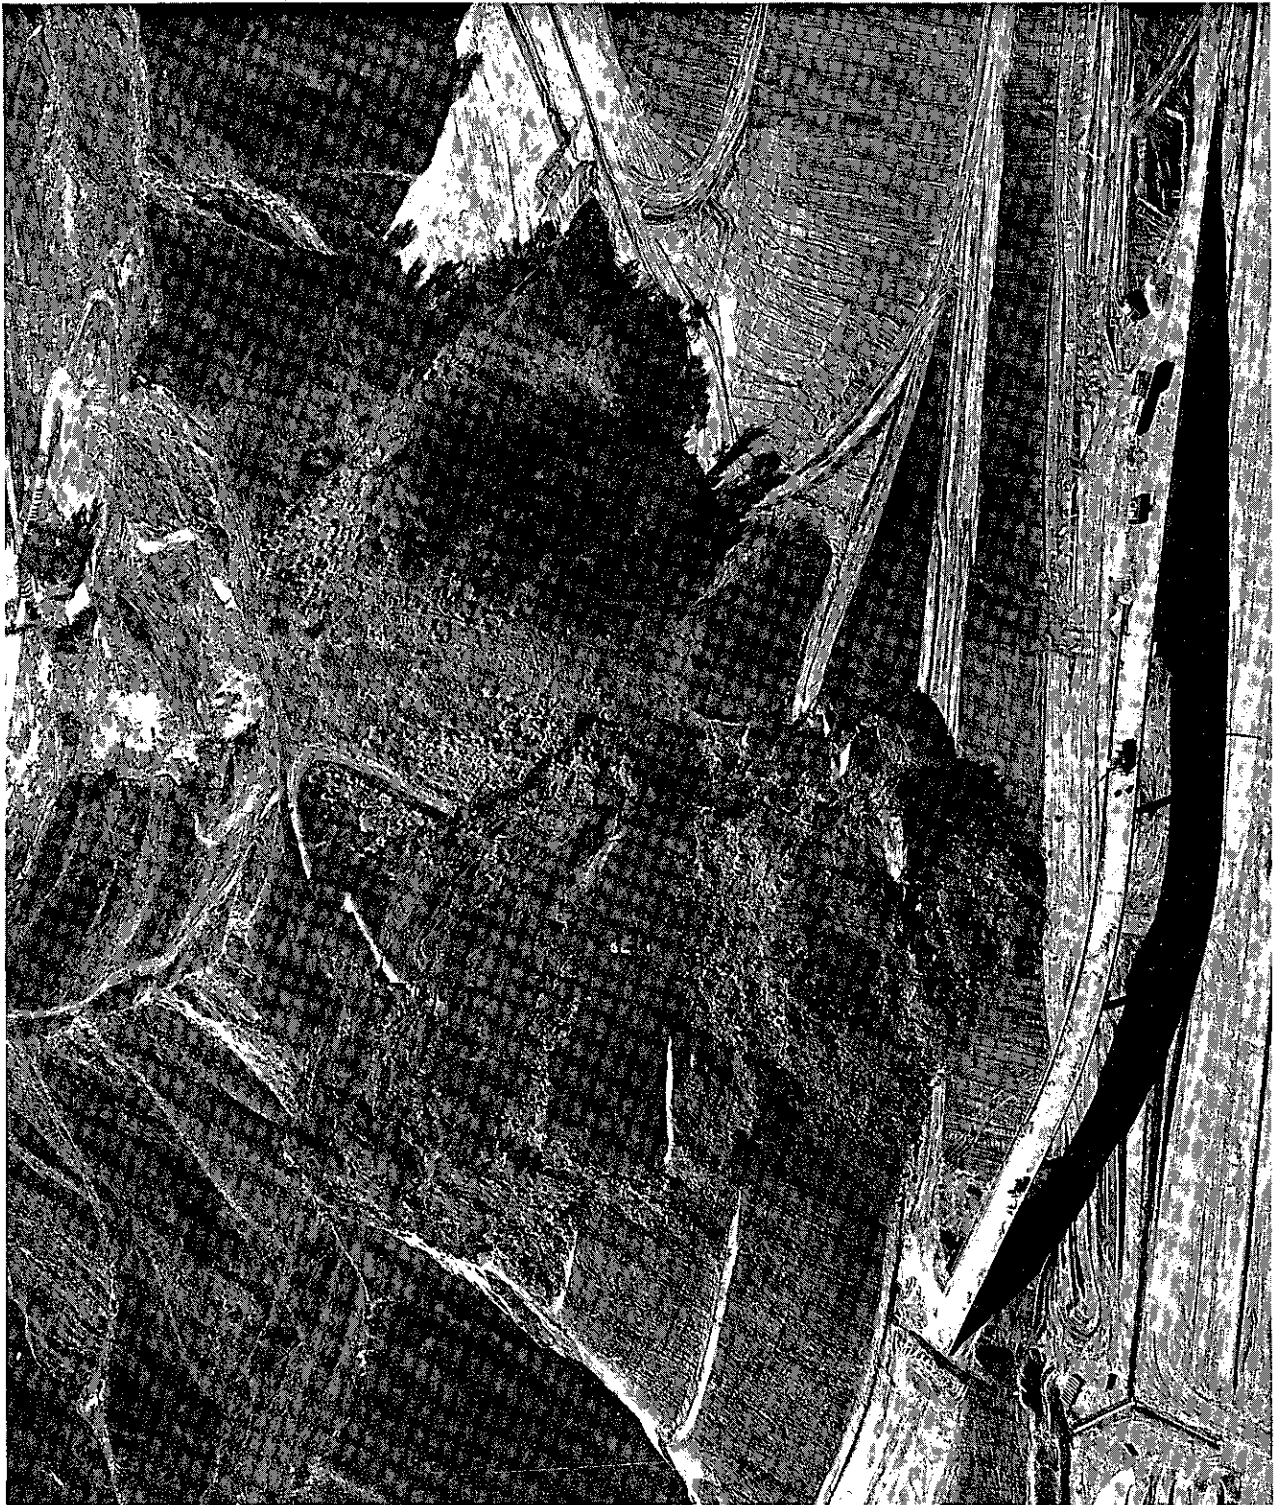
Figure 8 - Cut slope bedding plane failure left of  
Station 1640, Route 5.

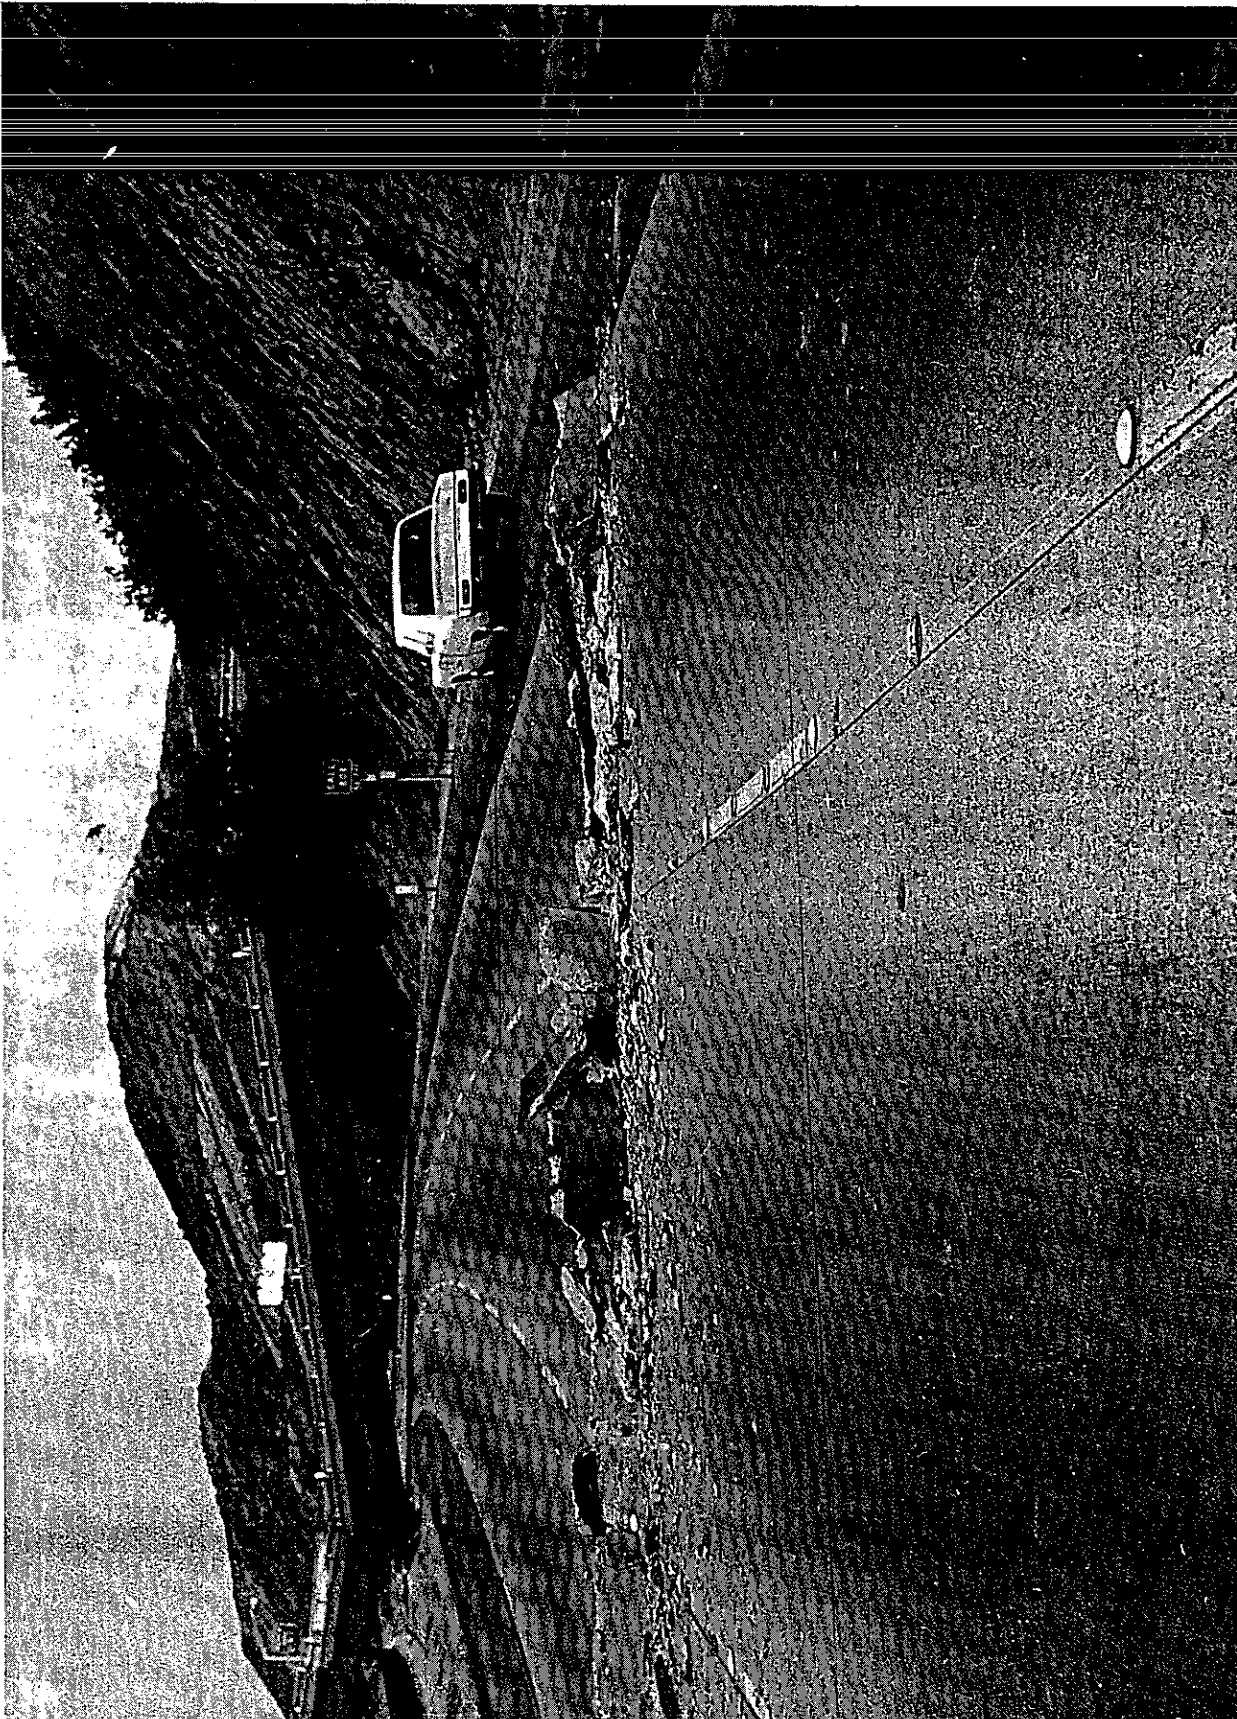
Figure 9 - Collapsed Route 5 (Truck Lane)/405 separation structure and buckling in pavement.

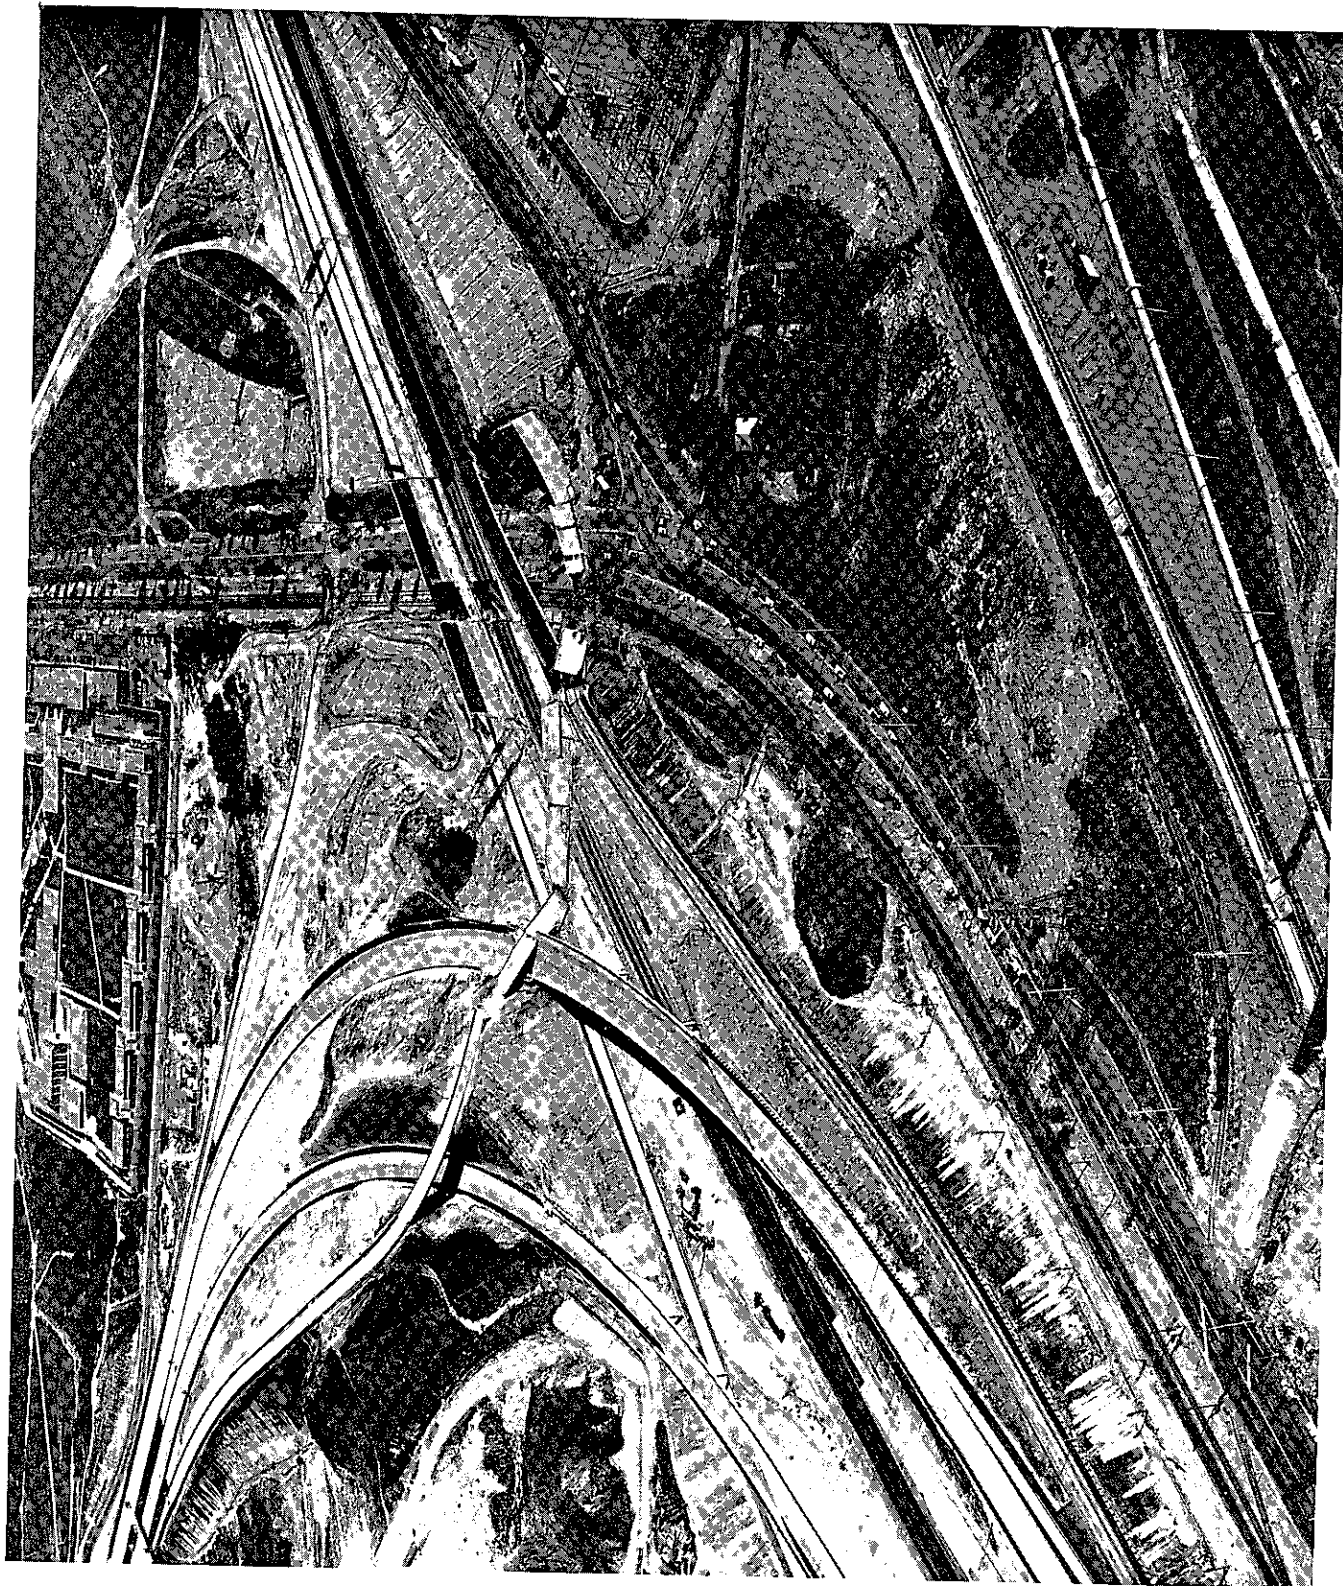
Figure 10 - Aerial view of Route 5/210 Interchange showing damaged structures.

A portion of one of the structures that failed at the Route 5/210 Interchange was constructed with steel girders. All the other freeway structures in the immediate vicinity were of concrete construction. Two other steel structures on the freeway system (Pico-Lyons Overcrossing and Valencia Boulevard Overcrossing) suffered only minor damage but are somewhat removed from the area of large energy release. However, a steel railroad structure is located in the vicinity of the Route 5/210 Interchange just north of the Sylmar Power Converter Station and immediately west of San Fernando Road. The overall effect of the quake on this structure is remarkably similar to that on the Pico-Lyons Overcrossing. The bridge is part of a spur line under construction to serve the Metropolitan Water District's Balboa Water Treatment Plant, also under construction just north of the upper Van Norman Lake. The bridge spans the Los Angeles Aqueduct and the 8-foot penstock that feeds the San Fernando Power Plant, and consists of six spans, each simply supported, of double wide flange steel beams. Abutments are of the old (especially rural) highway type, consisting of a backwall and flared wings (cantilevered) with bearing probably being attained with piles. Timbers had been placed across the beams but tracks had not been laid over the structure or on approach fills. Design of the structure is simple and effective for its intended purpose. Visible reaction of the bridge to the quake consisted of a slight ( $1/8''$ - $1/4''$ ) inward movement of both abutments as shown by bearing assemblies, perhaps one inch of approach fill subsidence, and a hairline crack in the north wingwall of the east abutment. It is difficult to assess the severity of ground motion and shocks in the very immediate area of the structure, but very large ground breakage and movements occurred a few hundred feet to the west.
